Manhole Inspection Summary

Manhole # S35KK_016MH

Location Address: **1826 SAINT PAUL ST**

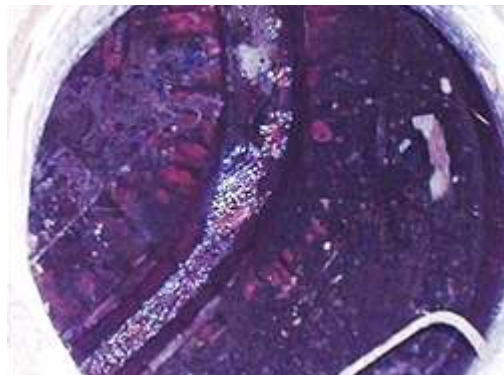
Top View

Evidence of surcharge - Bench debris.
Channel debris.

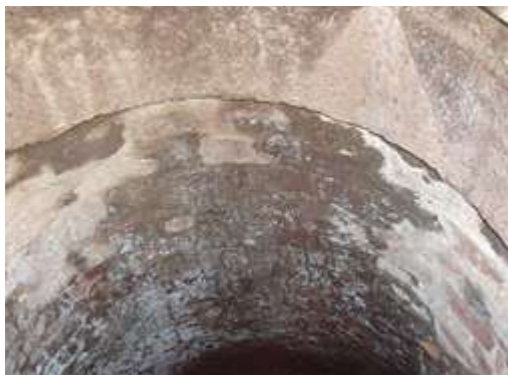
Defect

Frame leaks. Adjustment infiltration.

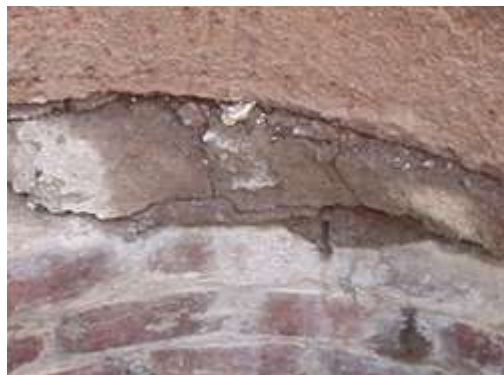
Defect

Frame leaks. Adjustment deterioration
and infiltration.

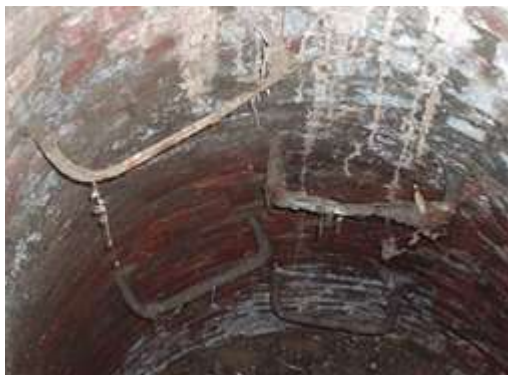
Defect

Corbel and Barrel infiltration. Corroded
steps.

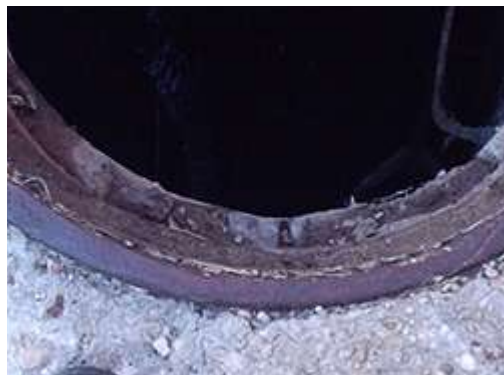
Defect

Frame offset.

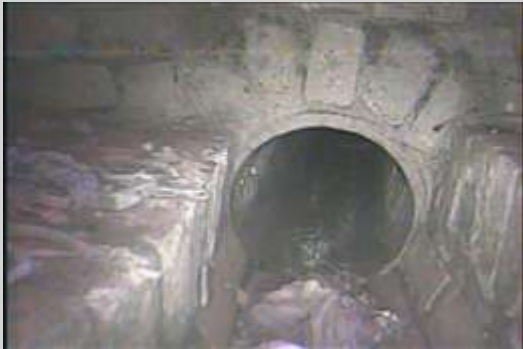
8 in. Circular Gravity Sewer Pipe Out @ 12 O'Clock

Deposits: ☐ None ☐ Mud ☐ Sludge ☒ **Debris** ☐ Grease

Silt Depth: **0** (in.) Deposits Extent: **Light**

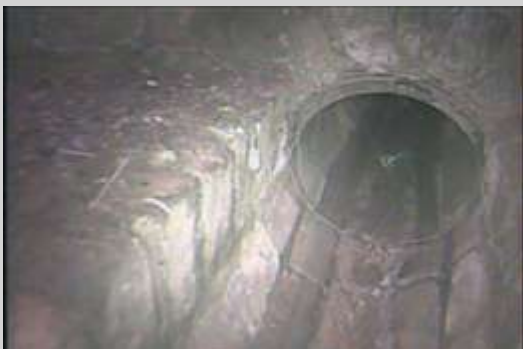
8 in. Circular Gravity Sewer Pipe In @ 7 O'Clock

Infiltration: **Evidence** Pipe Seal Cond: **Cracked**
